RE: Site Inspection, Ziegler Chemical and Mineral Corporation, Ziegler Gilsonite Mines,
M/047/013, Uintah County, Utah

Date of Inspection: December 11, 1995
Time of Inspection: 1250 - 1635
Conditions: Partly cloudy, cool
Participants: Norm Haslem, Bud Covington, Ziegler Chemical; Tony Gallegos, DOGM

Purpose of Inspection: To examine the proposed new mine site and verify the status of various mine sites included in the permit

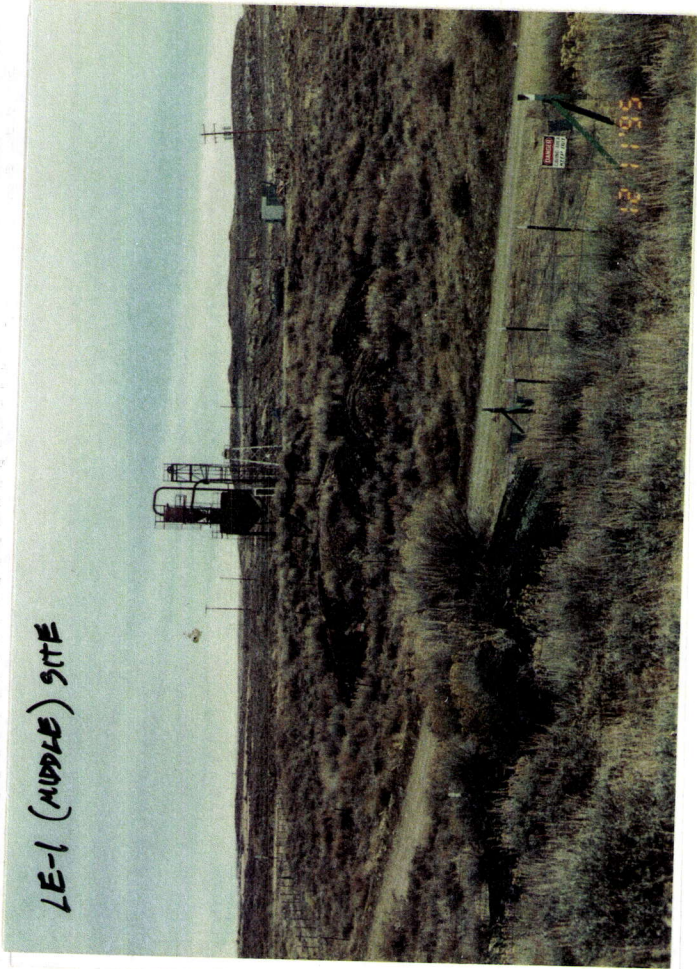
LE-1 (MIDDLE) SITE

We drove around several of the mine sites, in particular, through the LE-1 or middle site, which is still active. A photograph was taken of this area with the significant features being a head frame with a fence around it and a shaft site with warning signs.

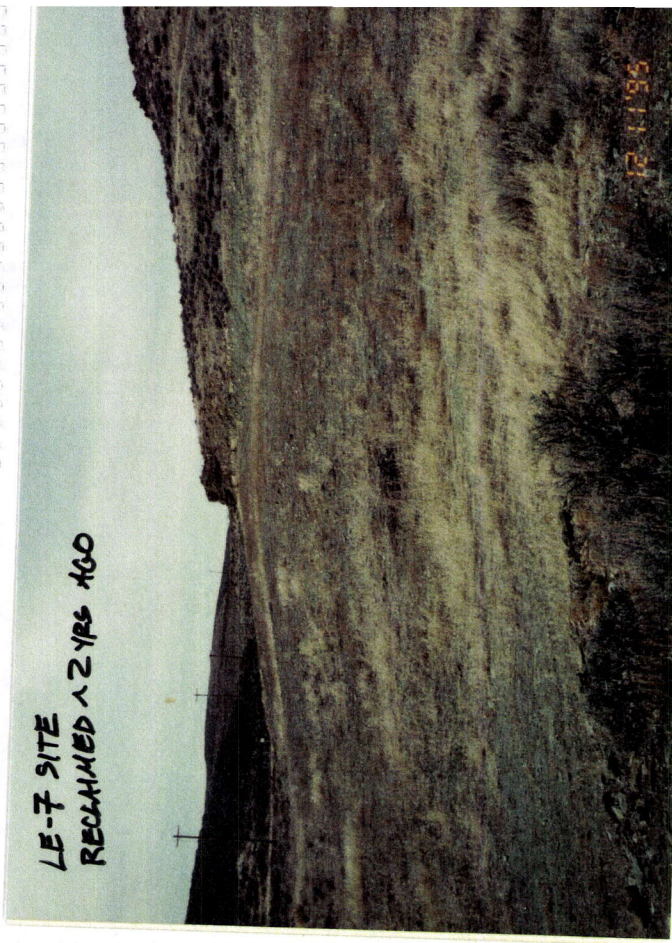
LE-7 SITE
RECLAIMED ~ 2 YRS AGO

We visited the LE-7 site which has been reclaimed approximately two years ago. Photographs were taken of this area. An identifying feature in the photo would be a gate on a road in the lower left portion. Mr. Covington had to leave after visiting this site.

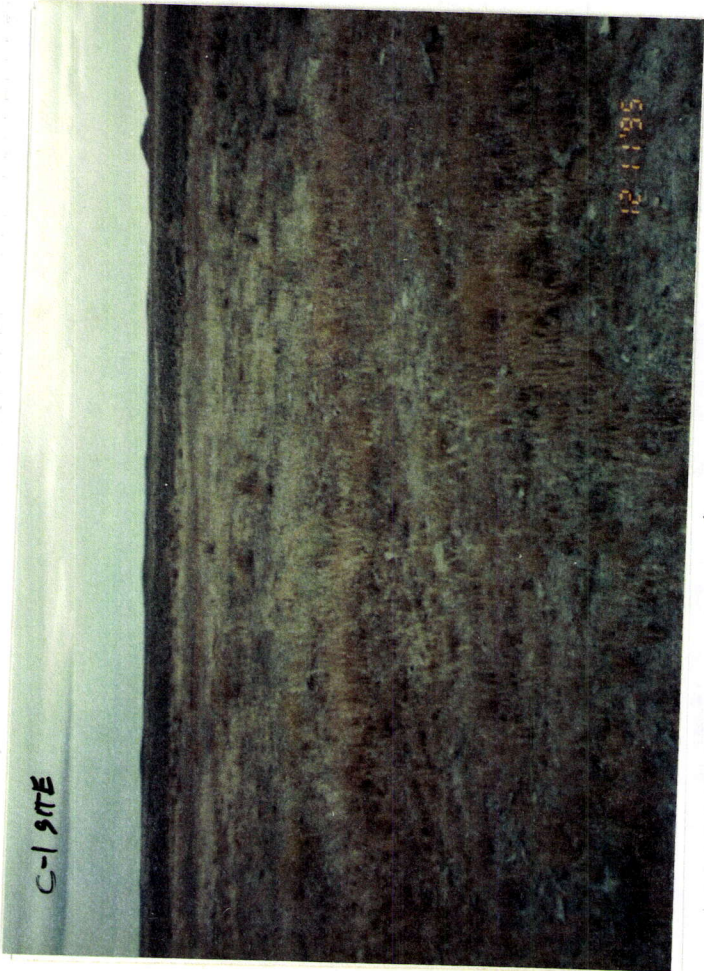
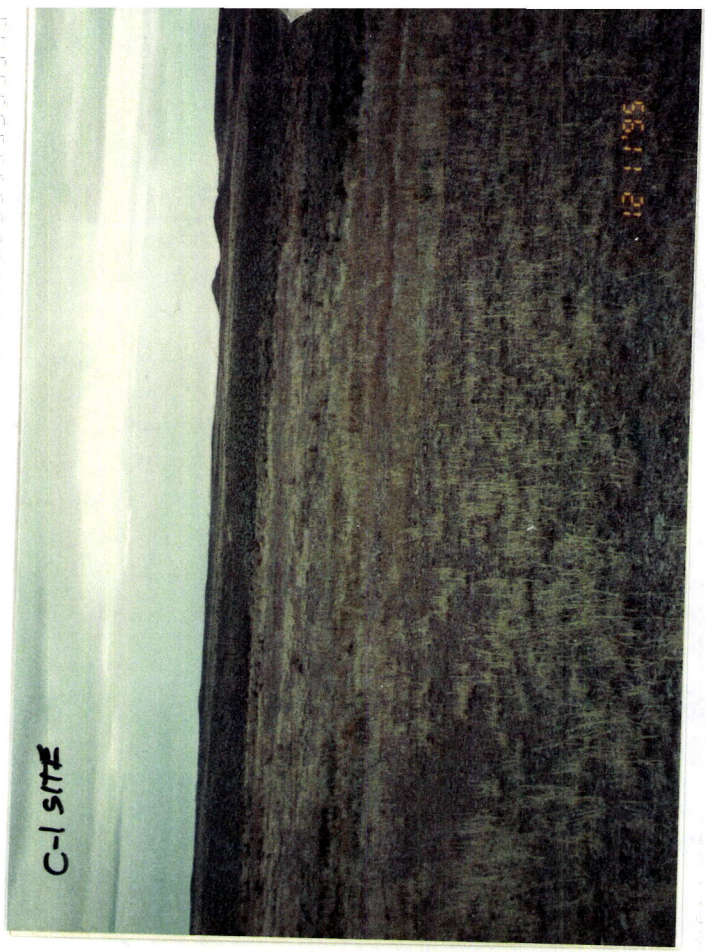
C-1 SITE

At the Cottonwood #1 site, there is a concrete cap over the shaft. This is what Ziegler has referred to as a coffin cap. Photographs were taken looking south towards this area. The photo should show that the area has been regraded. There will also be a noticeable difference between the natural vegetation and the reclamation vegetation. The Cottonwood C-2 site is northwest of the C-1 site and visible from here. No shaft was sunk at the C-2 site. The C-2 site was graded and a head frame erected, but nothing else was constructed. These surface features were removed and the site regraded and reseeded. The C-2 area is generally flat and rolling. Photographs were taken to document this area. Distinguishing features in the photo would include the sunset in the background. A closeup photo was taken of the concrete coffin cap at the C-1 shaft site. At the C-1 site was a small area covered with a thin layer of gilsonite. Norm asked if this was a problem, but since vegetation is coming through, I don't believe additional reclamation work would be warranted for this small spot.
